Geophysical Assessment of Pavement Failure Along the Ikere-Iju Road, Southwestern Nigeria, Using 2D Electrical Resistivity Imaging

Background and Objective: Pavement failure along the Ikere-Iju road in Southwestern Nigeria has become a persistent issue, affecting transportation and safety. Subsurface geological conditions are suspected to be a major contributing factor. This study aims to investigate the causes of the failure using 2D electrical resistivity imaging. The objective is to delineate weak zones and provide geophysical insights for effective road rehabilitation. **Materials and Methods:** A geophysical investigation was conducted to analyze the causes of persistent pavement failure along the Ikere-Iju road, Southwestern Nigeria, and propose mitigation measures. Using 2D electrical resistivity imaging (ERI) with a dipole-dipole array, subsurface geological structures were examined. Resistivity data were collected along four 200 m long traverses with a target depth of 15 m. **Results:** The lateral and vertical variations in subsurface lithology, distinguishing failed and stable road segments. The presence of extensive clayey topsoil, cavities, and faulted zones contribut

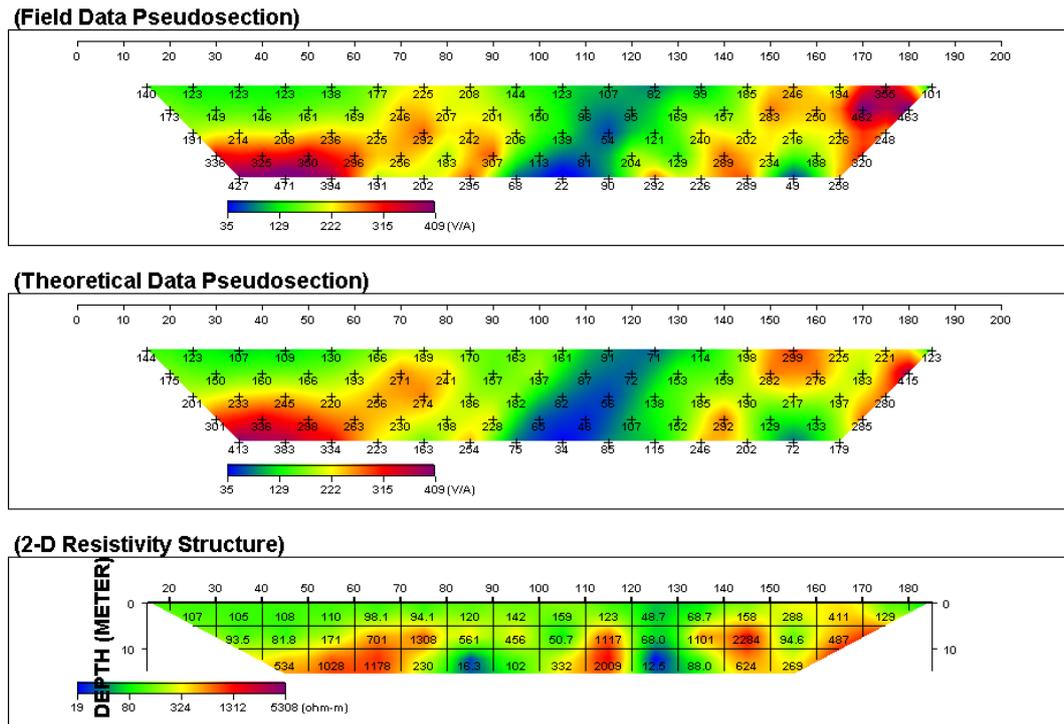
Fig. 4: Pseudo-section along traverse

The processed ERI data are presented as pseudo-sections with resistivity units indicated with a range of colors. The result obtained from ERI helps to delineate lithology variation, with results showing the availability of clayey materials, laterite, and cavity/faults in the subsurface of the study area. The pseudo-section (Fig. 4) along traverse 1 shows the subsurface image vertical and lateral variation of the lithology. The upper layer along traverse 1 shows a low to moderate resistivity value range between 48 and 120 ohm-m, and on some occasions 150-200 ohm-m, typical of clay, sandy clay and indurated clay

or typical lateritic formation at stations 30-60, 80-110 and 120-140 m. The depth of the lithological variation ranges between 0-5 m. A large fault is delineated between stations 80-110 and 120-140 m. This extends beyond 15 m under the zones of investigation. Geological materials interpreted to be clay (12-16 ohm-m) is also delineated. Competent beds were delineated at stations 50-80, 110-120 and 140-170 m below the depth of 5 m. Apart from the clayey topsoil, the identified large fault/cavity between the stations is an important source of failure along the Ikere-Iju road. Although geologically, both laterite and clay are considered typical confinement materials which also constitute a natural barrier to contaminant or pollutant flow, except where the confinement is breached during groundwater vulnerability assessment; however, clay is an enemy when the engineering properties of earth material are in perspective.

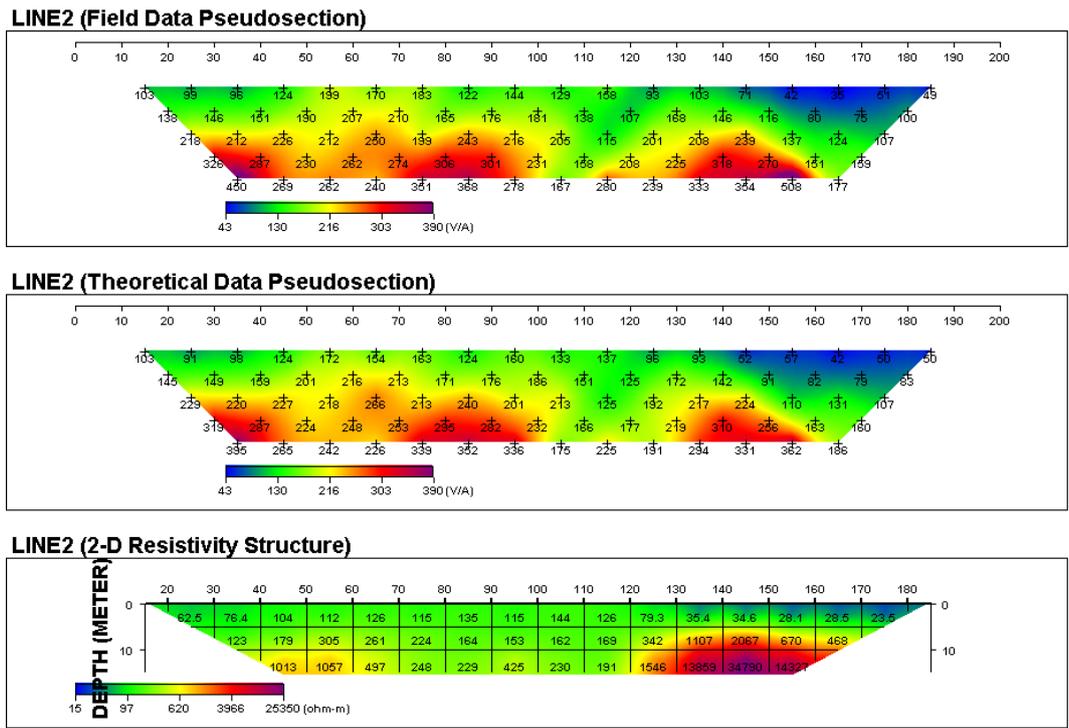
Fig. 5: Pseudo-section along traverse 2

The pseudo-section (Fig. 5) along traverse 2 shows the subsurface image vertical and lateral change of lithology. The upper layer along traverse 1 shows a low to moderate resistivity value range between 23 and 145 ohm-m, typical of clay and sandy clay along the entire traverse line. The depth of the lithological variation ranges between 0-5 m. Below a depth of 5 m is a noticeable transition of lithology from clay to indurated clay/laterite. A large clayey/lateritic portion is delineated between stations 20-130 m. This constitutes zones of weakness along the traverse and is pictured as a zone of depression that exhibits incessant failure. Competent beds were encountered below 5 m at stations 130-170 m. Apart from the clayey topsoil, the identified large fault/cavity between the stations is an important source of failure along the Ikere-Iju road.

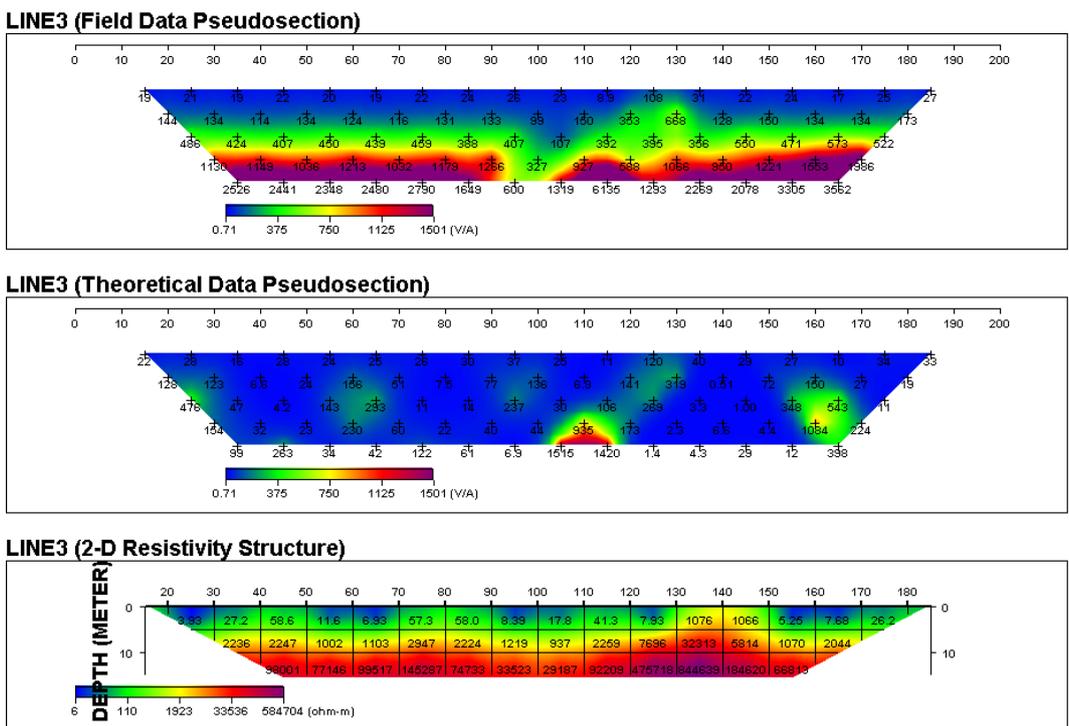
Fig. 6: Pseudo-section along traverse 3

The pseudo-section (Fig. 6) along traverse 3 shows the subsurface image of the lithology variation. The upper layer along traverse 3 shows a very low resistivity value range between 6.92-58 ohm-m, which is typical of clay formation along the entire traverse line. The depth of the low resistivity clay extends to about 7 m. The real competent formation is encountered below 7 m. Such depth could be considered the real foundation target where resources are available or where heavy road traffic is considered.

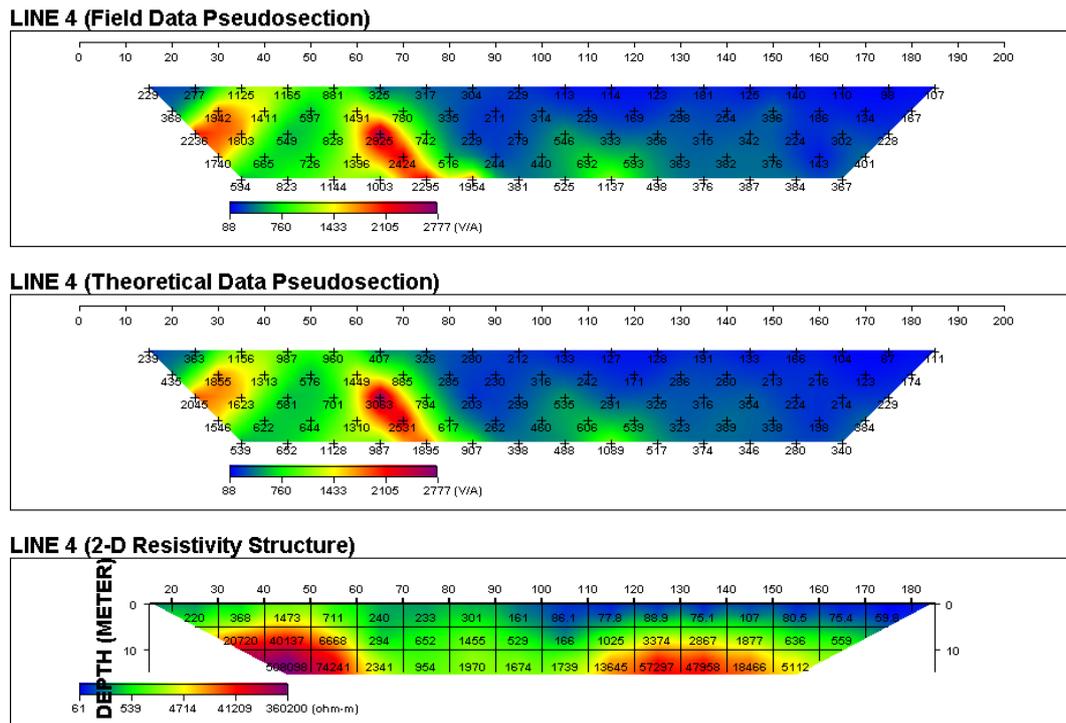
Fig. 7: Pseudo-section along traverse 4

The pseudo-section (Fig. 7) along traverse 4 shows the subsurface image of the lithology change. The upper layer along traverse 4 exhibits a very low to high resistivity value range of between 68, 305, and 1473 ohm-m, typical of clay, lateritic formation, and basement rock, which outcrop at the other side of the road. The very high resistivity, typical of basement rock, is encountered between stations 30 and 60 m. The lateritic portion is observed between stations 60 and 90 m, while the clayey portion is encountered between stations 90 and 180 m.

Below 5 m, a large fault/cavity is delineated between stations 60 and 110 m. The extensive clayey topsoil and the large fault encountered below the study location explain the reason for the incessant road failure along the Ikere-Iju roadway.
